## Old Church Renovations, 2010

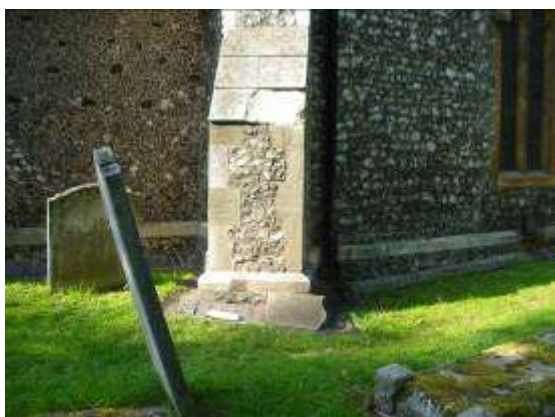
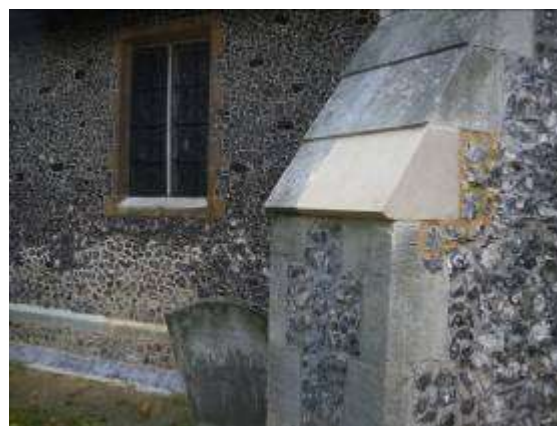
Here you see a large stone which had fallen off with the replacement in place and nicely bedded in with mortar. The new appearance will quickly disappear as the stone starts to blend in to the colour of the older stone.

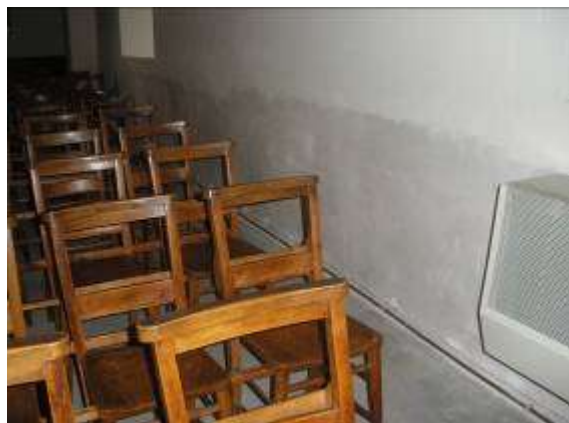
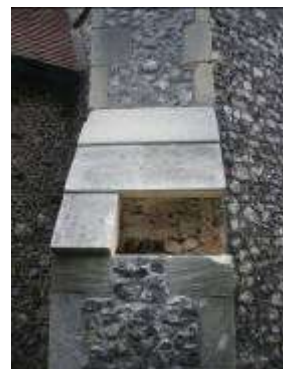
Here you can see the plaster on the interior and the same section of wall from the outside. The plaster hasn't been painted yet because we are waiting for it to fully dry out. It might take quite some time, but the contractor is checking regularly and will bring the painters in when the wall is fully ready for it. The work of pointing the exterior walls looked painful and detailed as the workers spent hours kneeling or bending to use their tools.

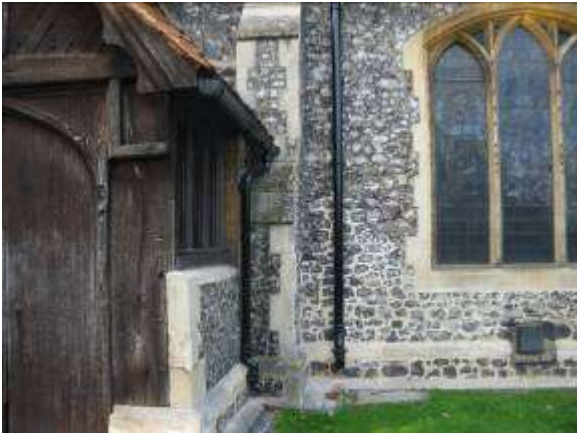
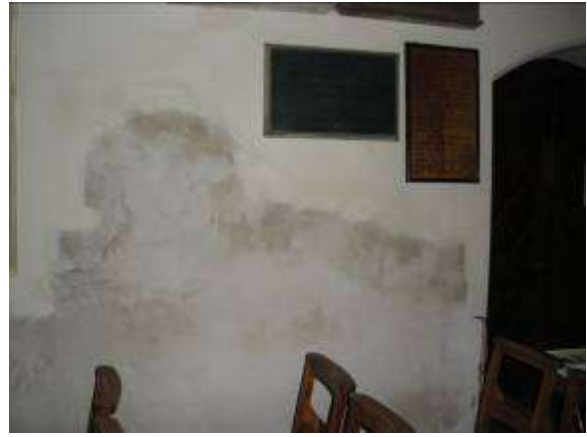
This is another example of the inside and outside of the same wall. The downspout on the left has been pouring water on to the wall, which had greenery flourishing out of the mortar before the work was done. The rainwater goods were all taken down and conserved as much as possible and new gutters purchased if necessary, using the same materials. John and Kevin spent a lot of time painting the gutters.

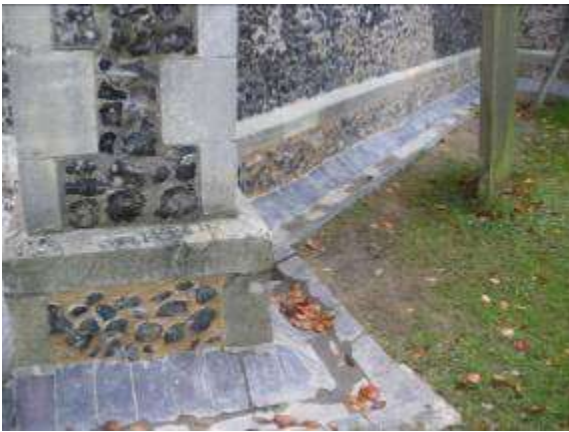
Here, just alongside Edward Betham's grave, you can see the new mortar in place and a long stretch of new work

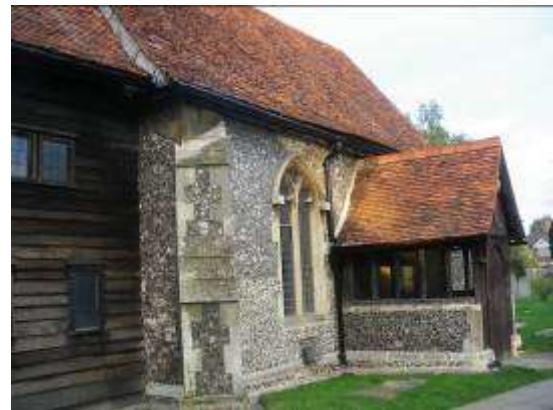
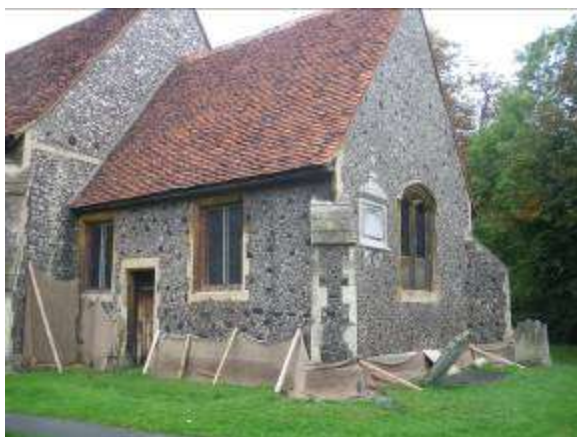
The foot scraper on the left had side of the porch came away recent due to the stone breaking up. A new stone now holds it in place and the gutters, although a bit wavy, are working very well for us.

The Old Church looked like an old lady wearing hessian skirts at times. This was to provide the newly laid mortar with protection for the frost which the architect, Ian Angus, had predicted. He was right!
